CRS No. A-00010

Name: Dwelling, 264 Bowers Beach Road

CULTURAL RESOURCE SURVEY
PROPERTY IDENTIFICATION FORM

1. HISTORIC NAME/FUNCTION: Dwelling, 264 Bowers Beach Road
2. ADDRESS/LOCATION: 264 Bowers Beach Road
3. TOWN/NEAREST TOWN: Little Heaven vicinity? ☒
4. MAIN TYPE OF RESOURCE: building ☒ structure ☐ site ☐ object ☐
 landscape ☐ district ☐
5. MAIN FUNCTION OF PROPERTY: Residential
6. PROJECT TITLE/ REASON FOR SURVEY (if applicable):
SR1, Little Heaven Grade Separated Intersection Improvements

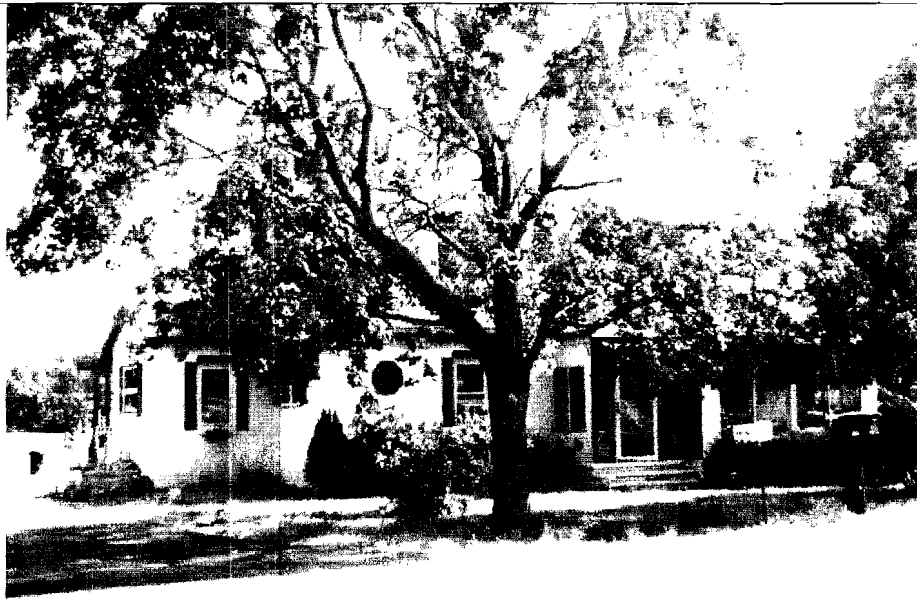
A-00010. Photograph 1: Overview of 264 Bowers Beach Road, looking southwest. This highly altered dwelling was constructed ca. 1958.

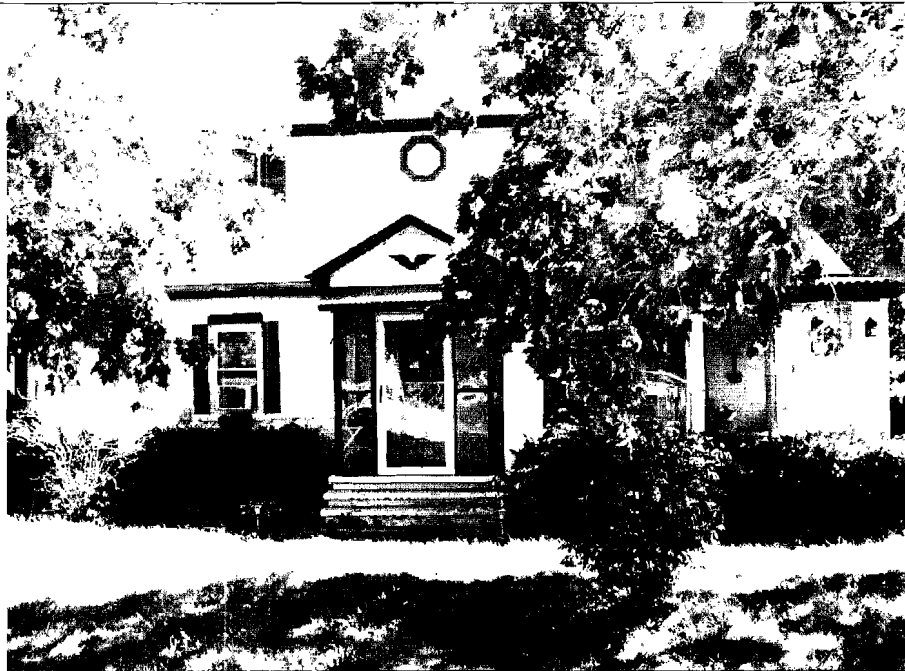
A-00010. Photograph 2: Dwelling, north elevation, looking south. The second-story addition was constructed ca. 1980. Also note the enclosed entry and side porches.

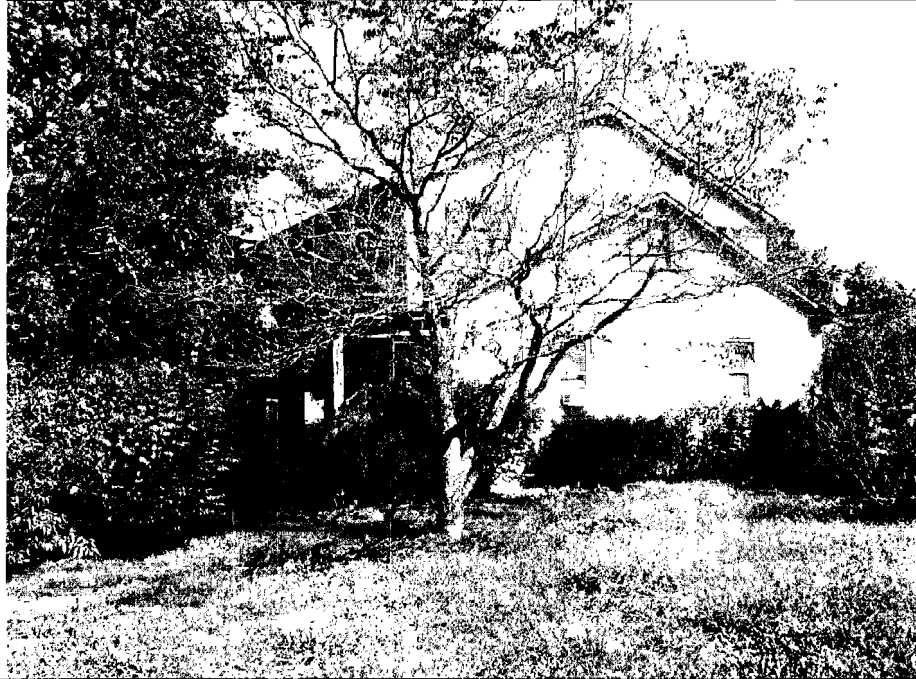
A-00010. Photograph 3: Dwelling, north and west elevations, looking southeast. Note the second-story addition, which has compromised the dwelling's integrity of design and feeling.

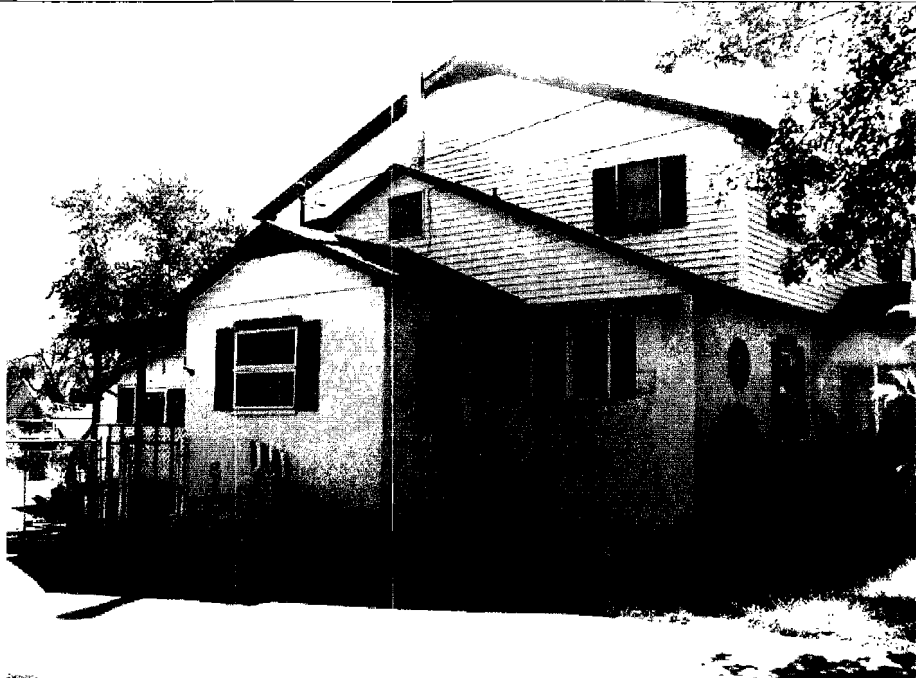
A-00010. Photograph 4: Dwelling, east elevation, looking southwest. Note the original hyphen, which is similar in form to those at the 239 and 249 Bowers Beach Road dwellings.

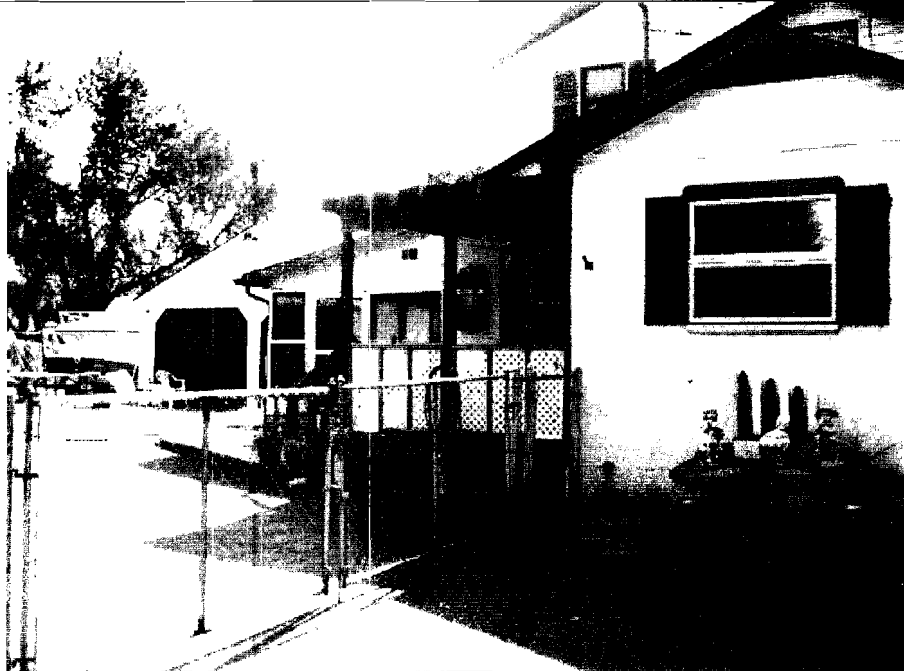
A-00010. Photograph 5: Modern garage and dwelling, east elevations, looking southwest. The southern half of the property was not accessible due to the enclosed fence.

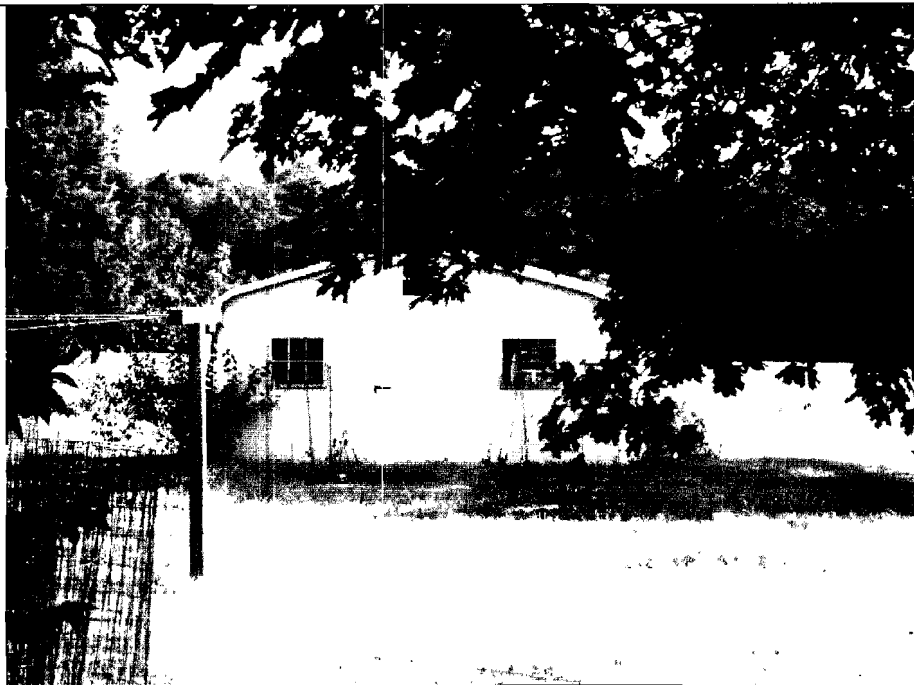
A-00010. Photograph 6: Modern shed, west elevation, looking east. This shed dates to ca. 1970.

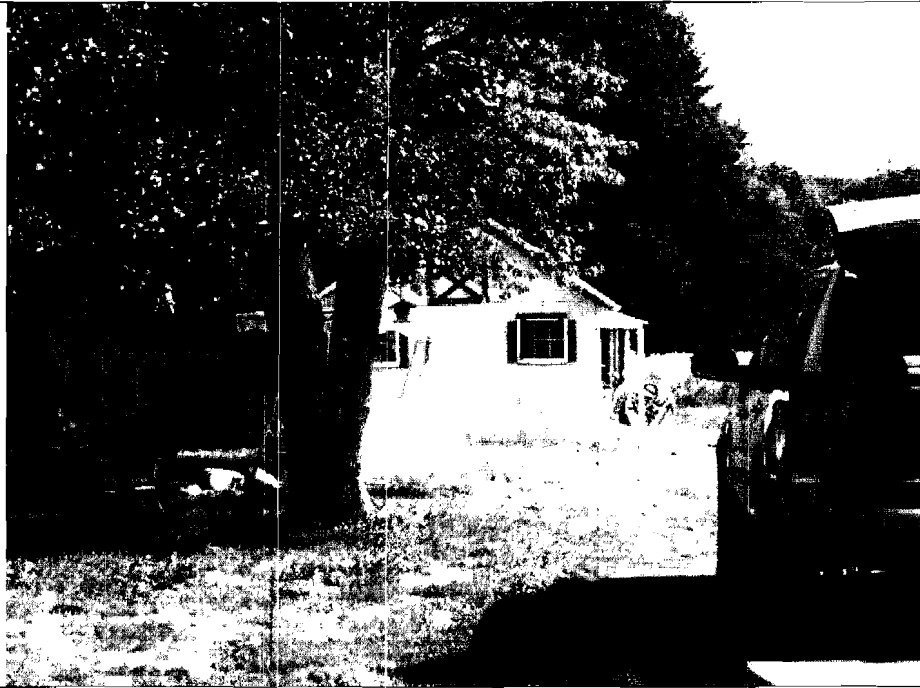
A-00010. Photograph 7: Modern shed, north elevation, looking south. This modern shed was erected ca. 1980 and was not accessible during the current survey.
